Smoke and Dye-Water Observation Summary

Western Run Pilot Project - Baltimore Maryland

INSPECTION REPORT

STREET:
 GLEN AVE. TEST 86 B 2
 MAP #1:
 1
 MH:
 1521351

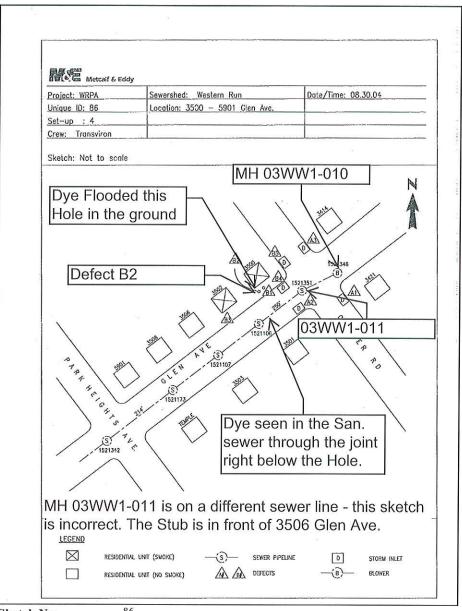
86

Dye Flooded this
Hole in the ground

Dye seen at the
joint directly below the Hole
